Manhole Inspection Summary

Manhole # S45E__062MH

Insp Date: **7/24/08 9:30 AM**

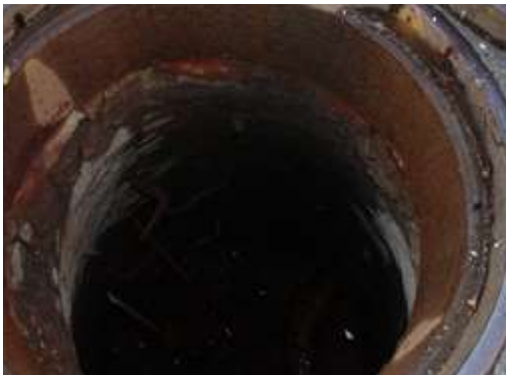
Defect 2

Infiltration: ☐ None ☐ Joint ☐ Cracks ☐ Mortar ☐ Roots ☒ **Wall**

Infiltration

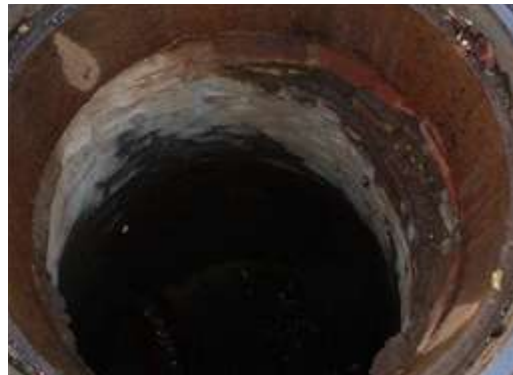
Defect 1

☒ **Leaks**

Frame Leaks

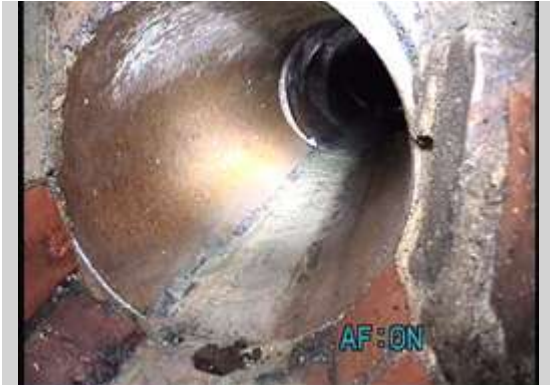
12 O'Clock Outflow

8 in. Circular Gravity Sewer
Pipe Out @ 12 O'Clock

Pipe Height: **8.4** (in.) Rod and Bar (Angled)
Pipe Material: **Clay** ☐ Pipe Lined
Invert Depth: **8.65** (ft.) Flow Characteristics: **Fast**
Deposits: ☒ None ☐ Mud ☐ Sludge ☐ Debris ☐ Grease
Silt Depth: (in.) Deposits Extent:
Infiltration: **None** Pipe Seal Cond: **Sound**

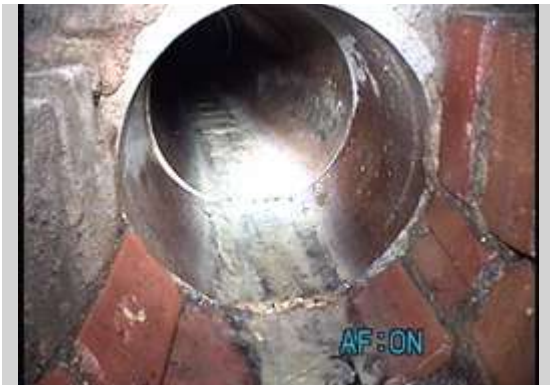
3 O'Clock Inflow

8 in. Circular Gravity Sewer
Pipe In @ 3 O'Clock

Pipe Height: **8.4** (in.) Rod and Bar (Angled)
Pipe Material: **Clay** ☐ Pipe Lined
Invert Depth: **8.55** (ft.) Flow Characteristics: **Fast**
Deposits: ☒ None ☐ Mud ☐ Sludge ☐ Debris ☐ Grease
Silt Depth: (in.) Deposits Extent:
Infiltration: **None** Pipe Seal Cond: **Sound**
